**ENVIRONMENTAL
SITE ASSESSMENT**

**UCD WEST VILLAGE
PROPERTY**

DAVIS, YOLO COUNTY

**WKA No.
6915.01**

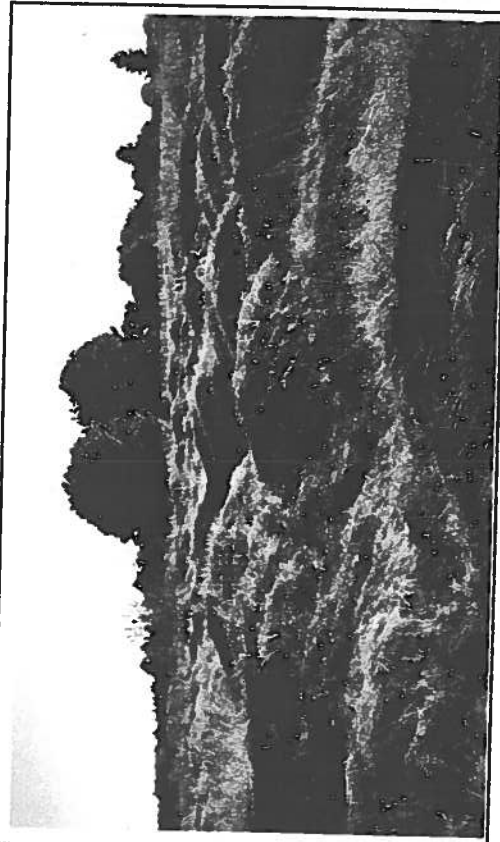
View of the "end dump" piles in the southeast corner of the property northeast of the Western Center for Equipment.

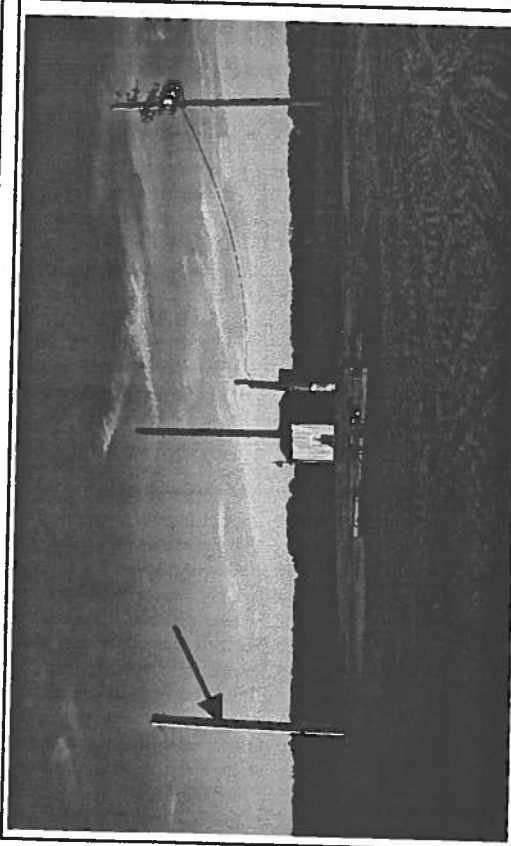
View of one of two on-site irrigation water supply wells. The white column feature on the left is an abandoned aphid trap (arrow).

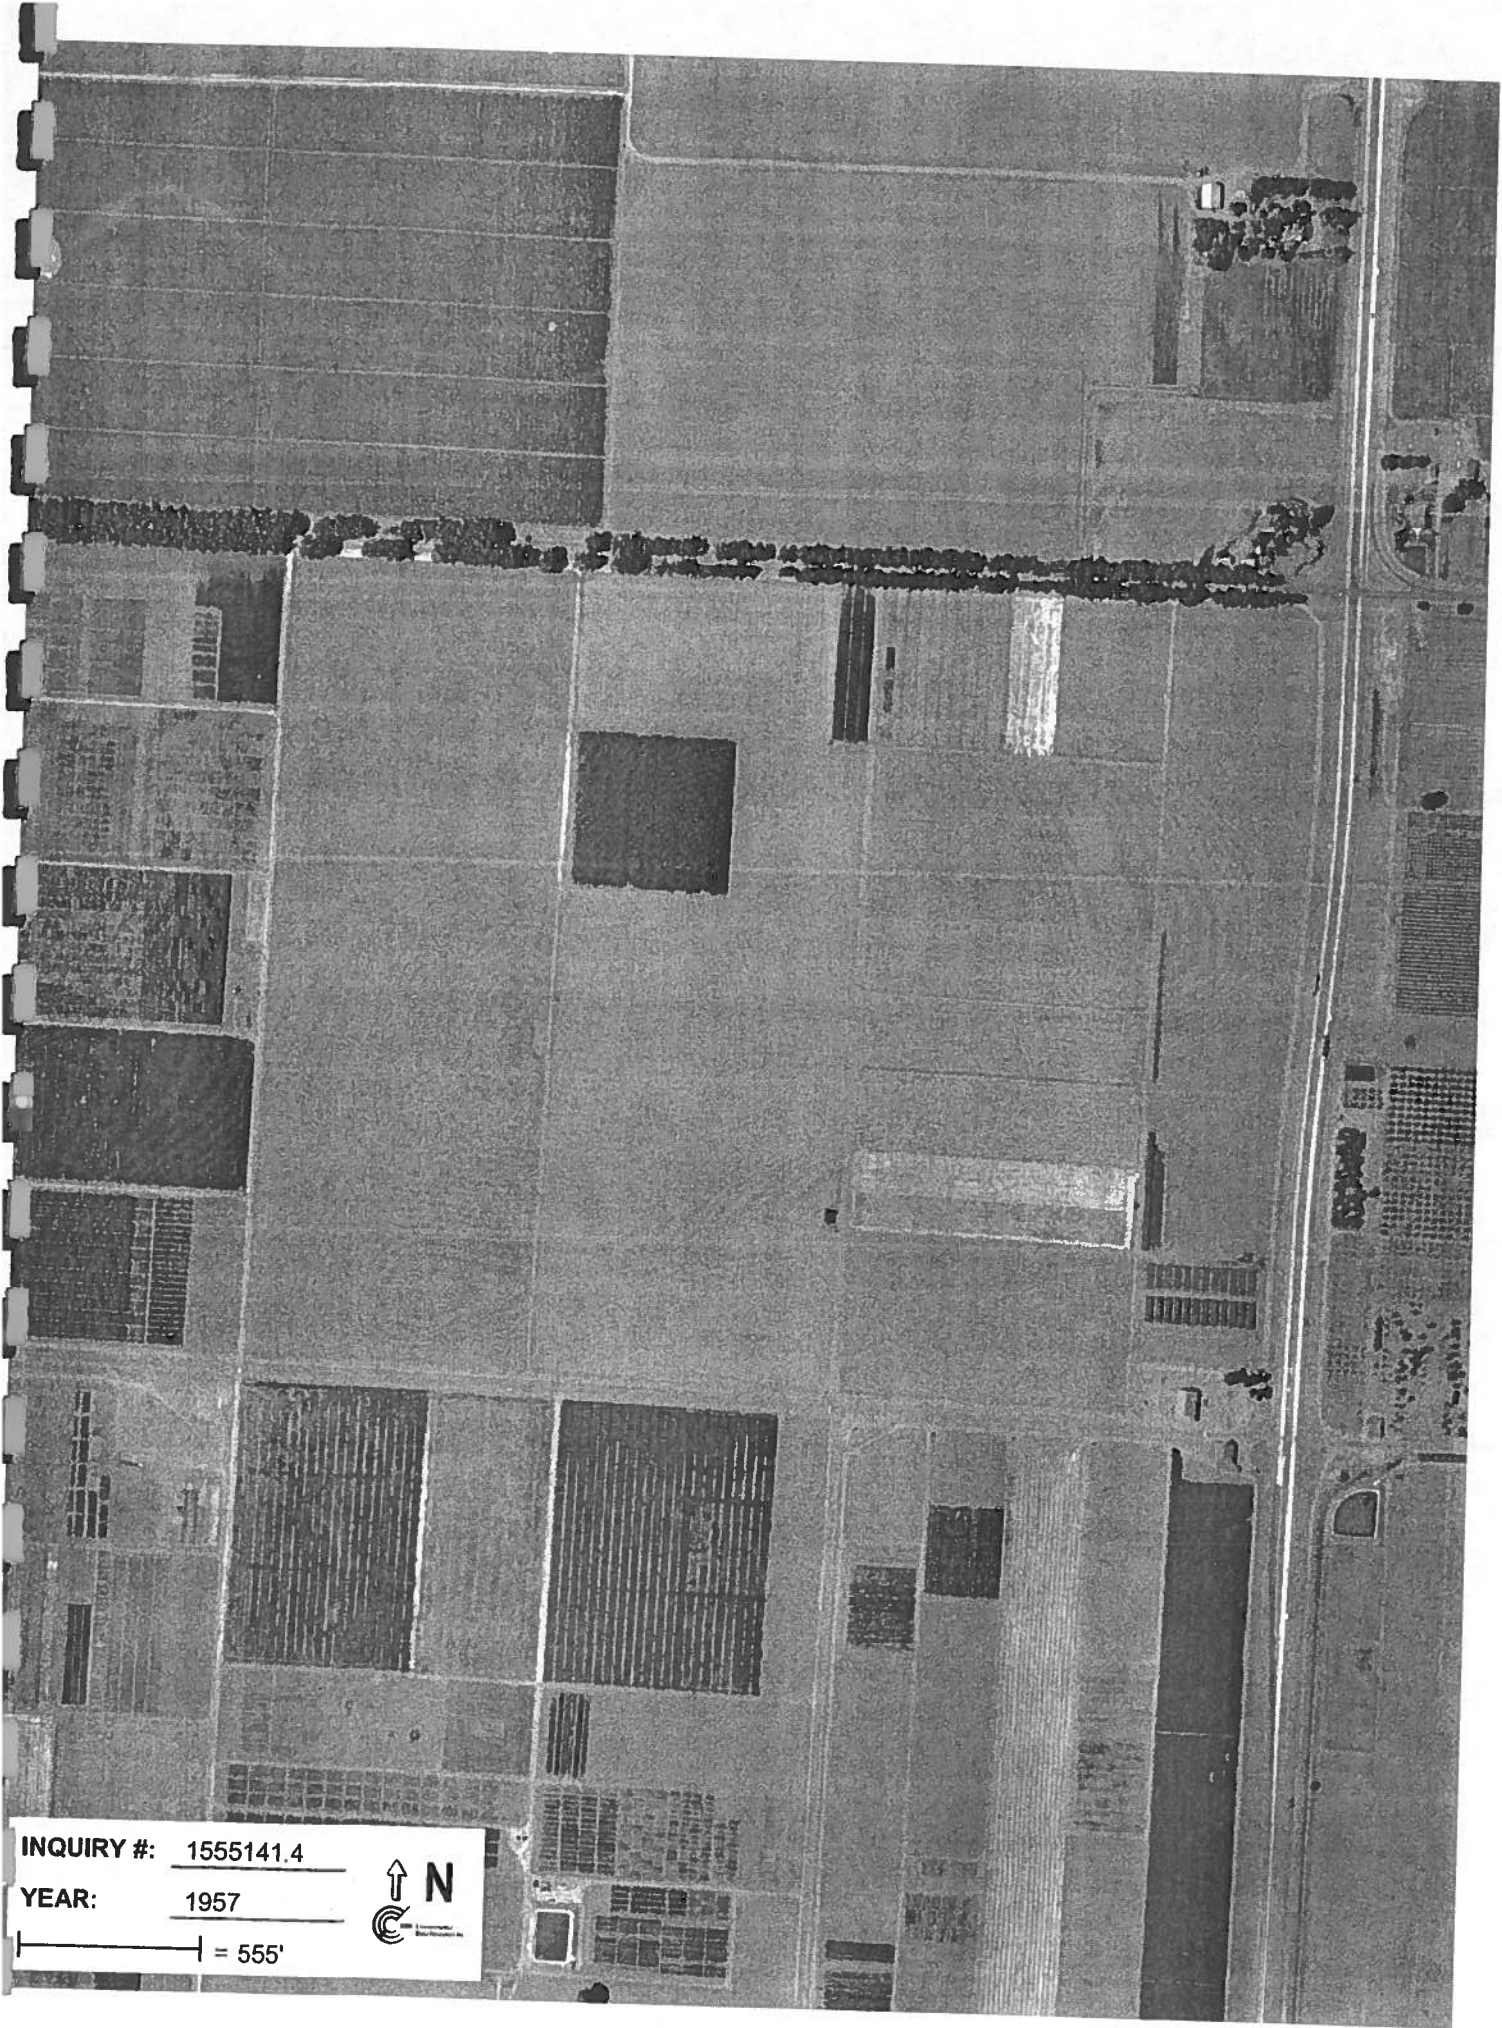
YEAR: 1957

The subject property is primarily agricultural land as shown on the 1957 photograph. The property is divided into separate "plots" apparently used for different crop types. Two structures are visible in the southeast corner of the property. One structure, on the north side of Hutchison Drive resembles a barn and the other, smaller structure located on the south side of Hutchison Drive, resembles a small shed or similar barn. Highway 113 is visible to the east of the property. Across the northern property boundary, an east-west trending line of trees is visible along what is now referred to as Russell Boulevard. Hutchison Drive is visible along the southern side of the property.

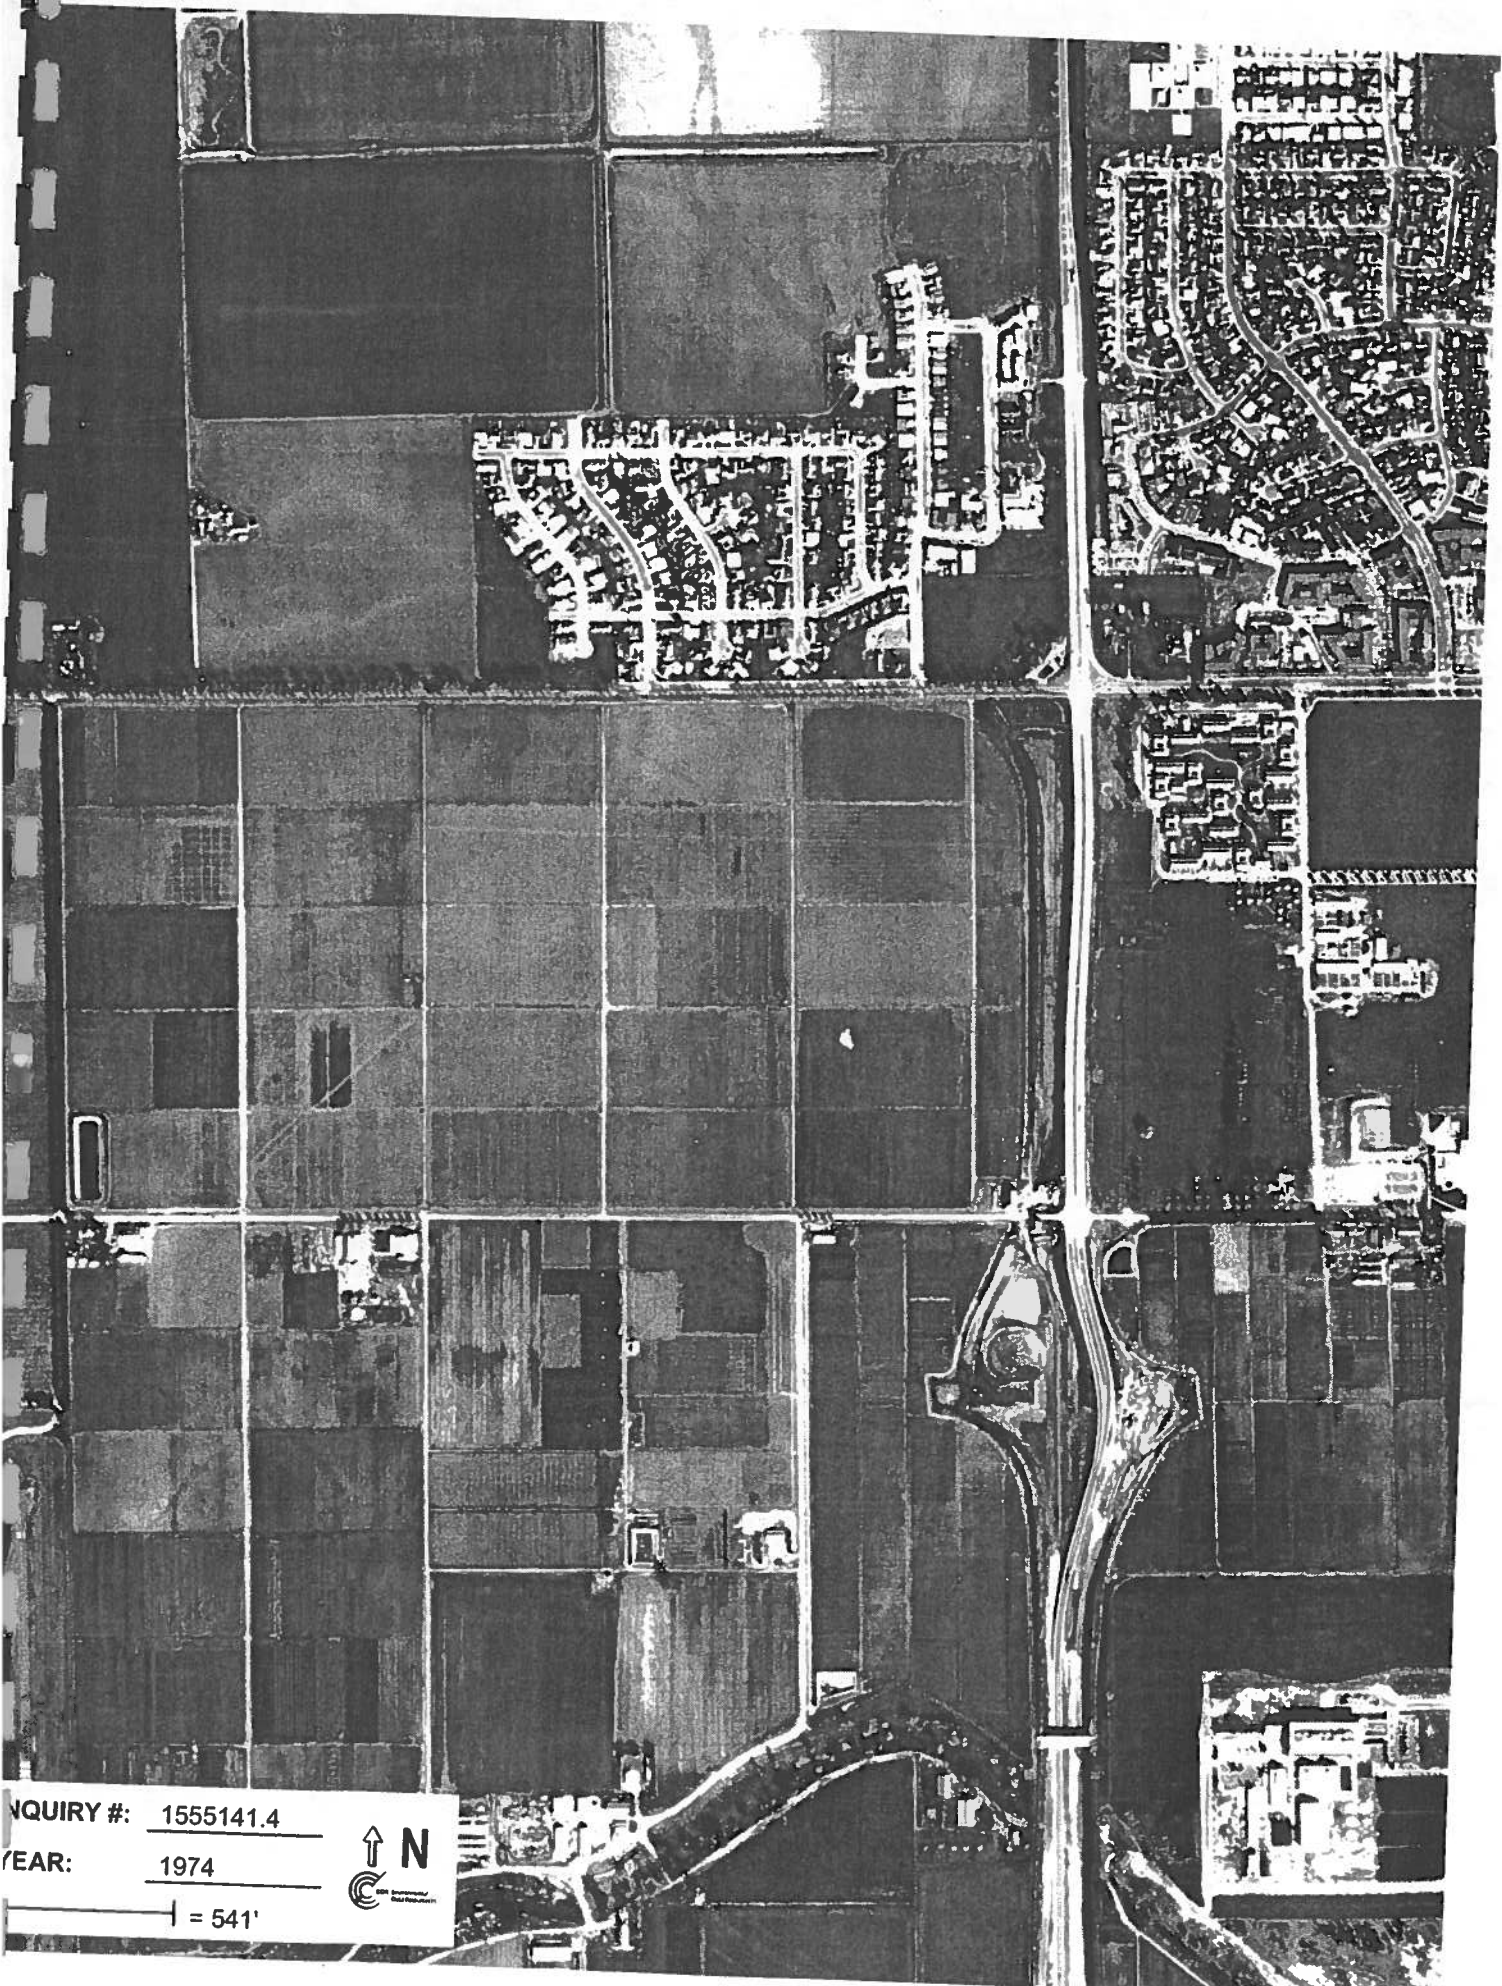
YEAR: 1974

By 1974, the subject property has changed little with respect to previous years. The agricultural plots are still visible and actively farmed. A residential neighborhood is visible to the north of the subject property beyond Russell Boulevard. The barn-type structure located in the southeast corner of the property is still visible along with five apparent silos immediately west of the barn-structure. Highway 113 has been constructed into a "dual highway" that parallels the eastern portion of the property. South of the barn area, construction is visible on what appears to be a highway interchange or "cloverleaf" related to Highway 113. Grading for an on-ramp/off-ramp between Russell Boulevard to the north and Hutchinson Drive to the south is visible along the eastern property boundary.

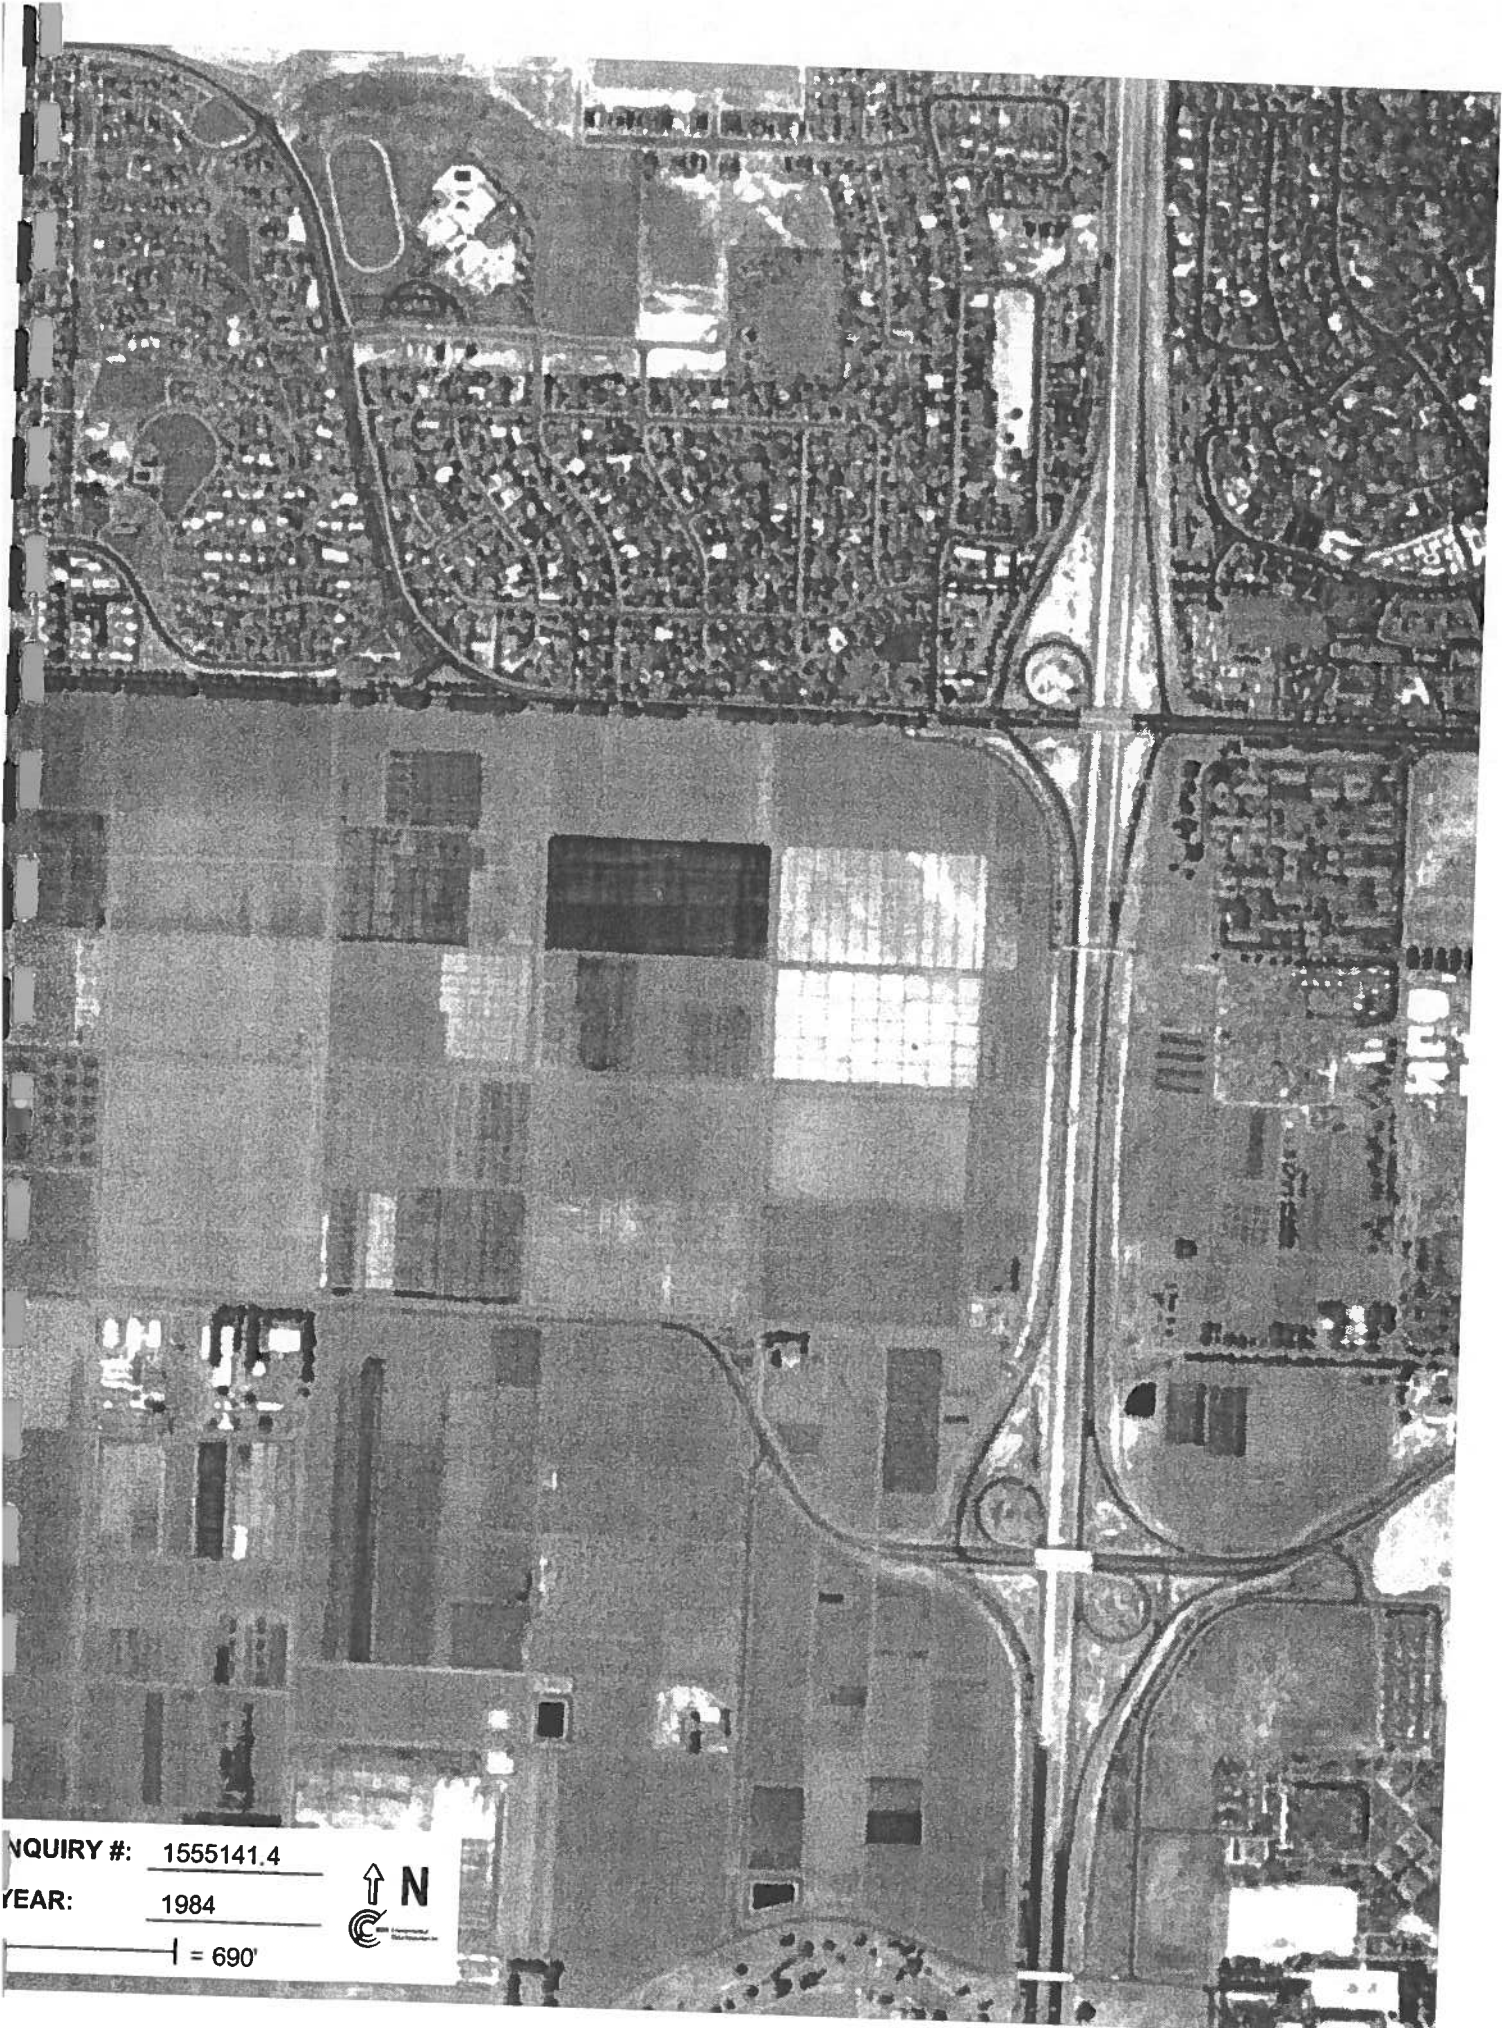
YEAR: 1984

The subject property remains agricultural in 1984. The previously discussed plots are clearly visible in the 1984 photograph. The crops within each plot have changed relative to previous photographs. Construction of the Hutchinson Drive interchange has been completed by 1984. Hutchinson Drive has been routed south from its original location such that it was incorporated into the interchange. Surrounding residential development is evident north and northwest of the subject property.

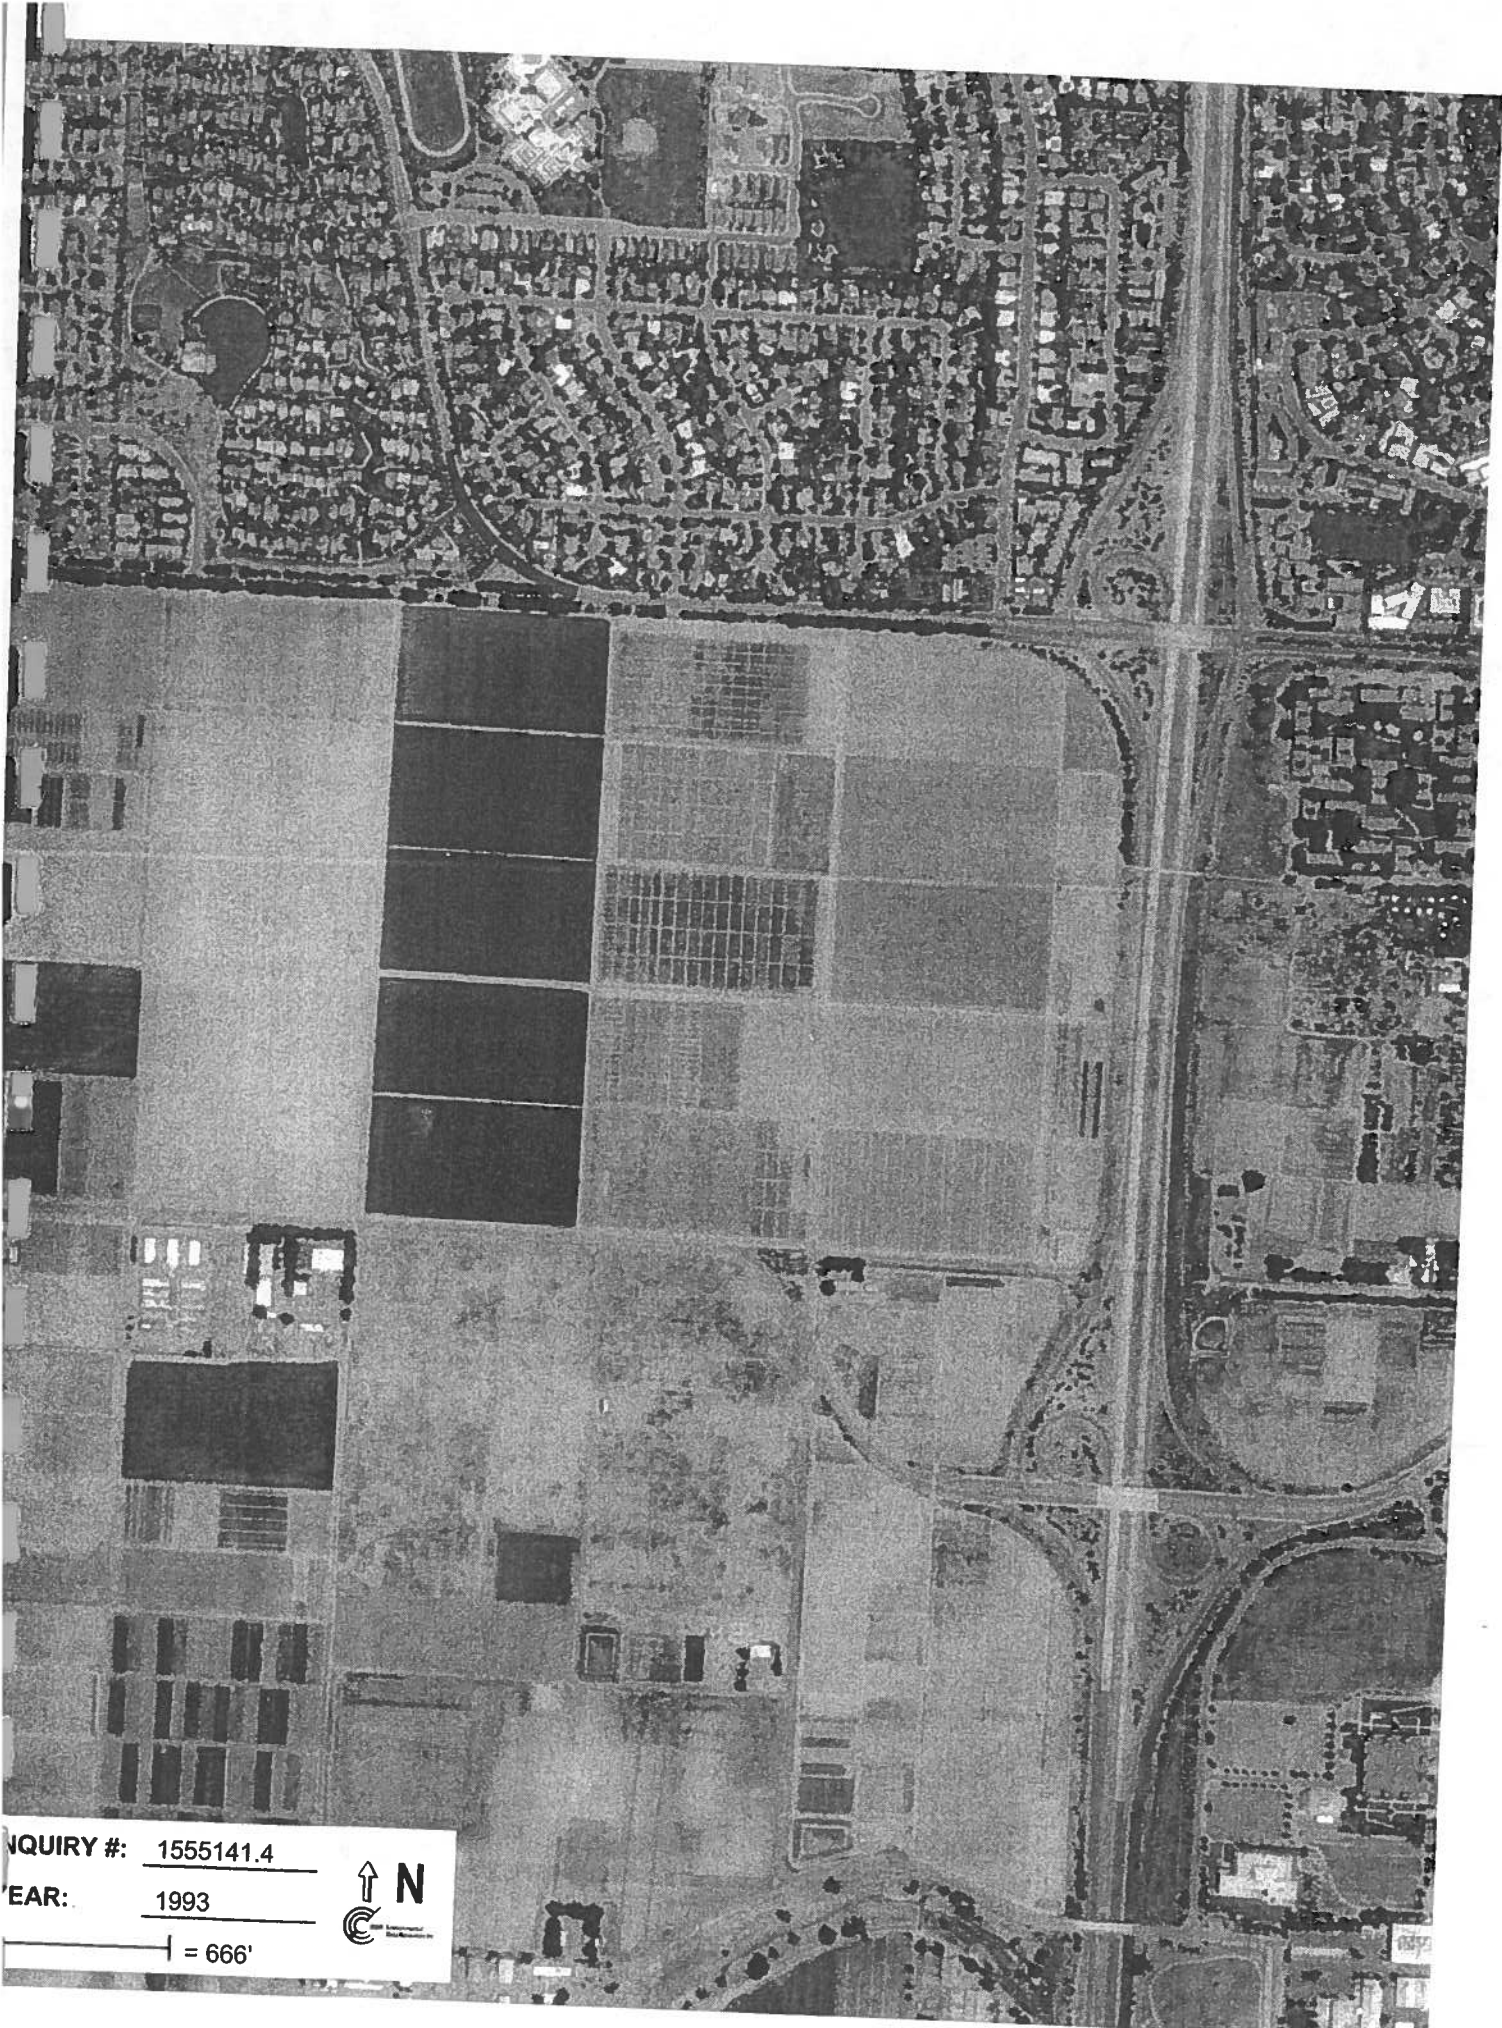
INQUIRY #: 1555141.4
YEAR: 1993

No significant changes are noted on the 1993 aerial photograph relative to 1984. The subject property is being utilized for agricultural purposes with the distinct plots readily visible in the photograph. A copy of the 1993 aerial photograph is included in Figure 4.

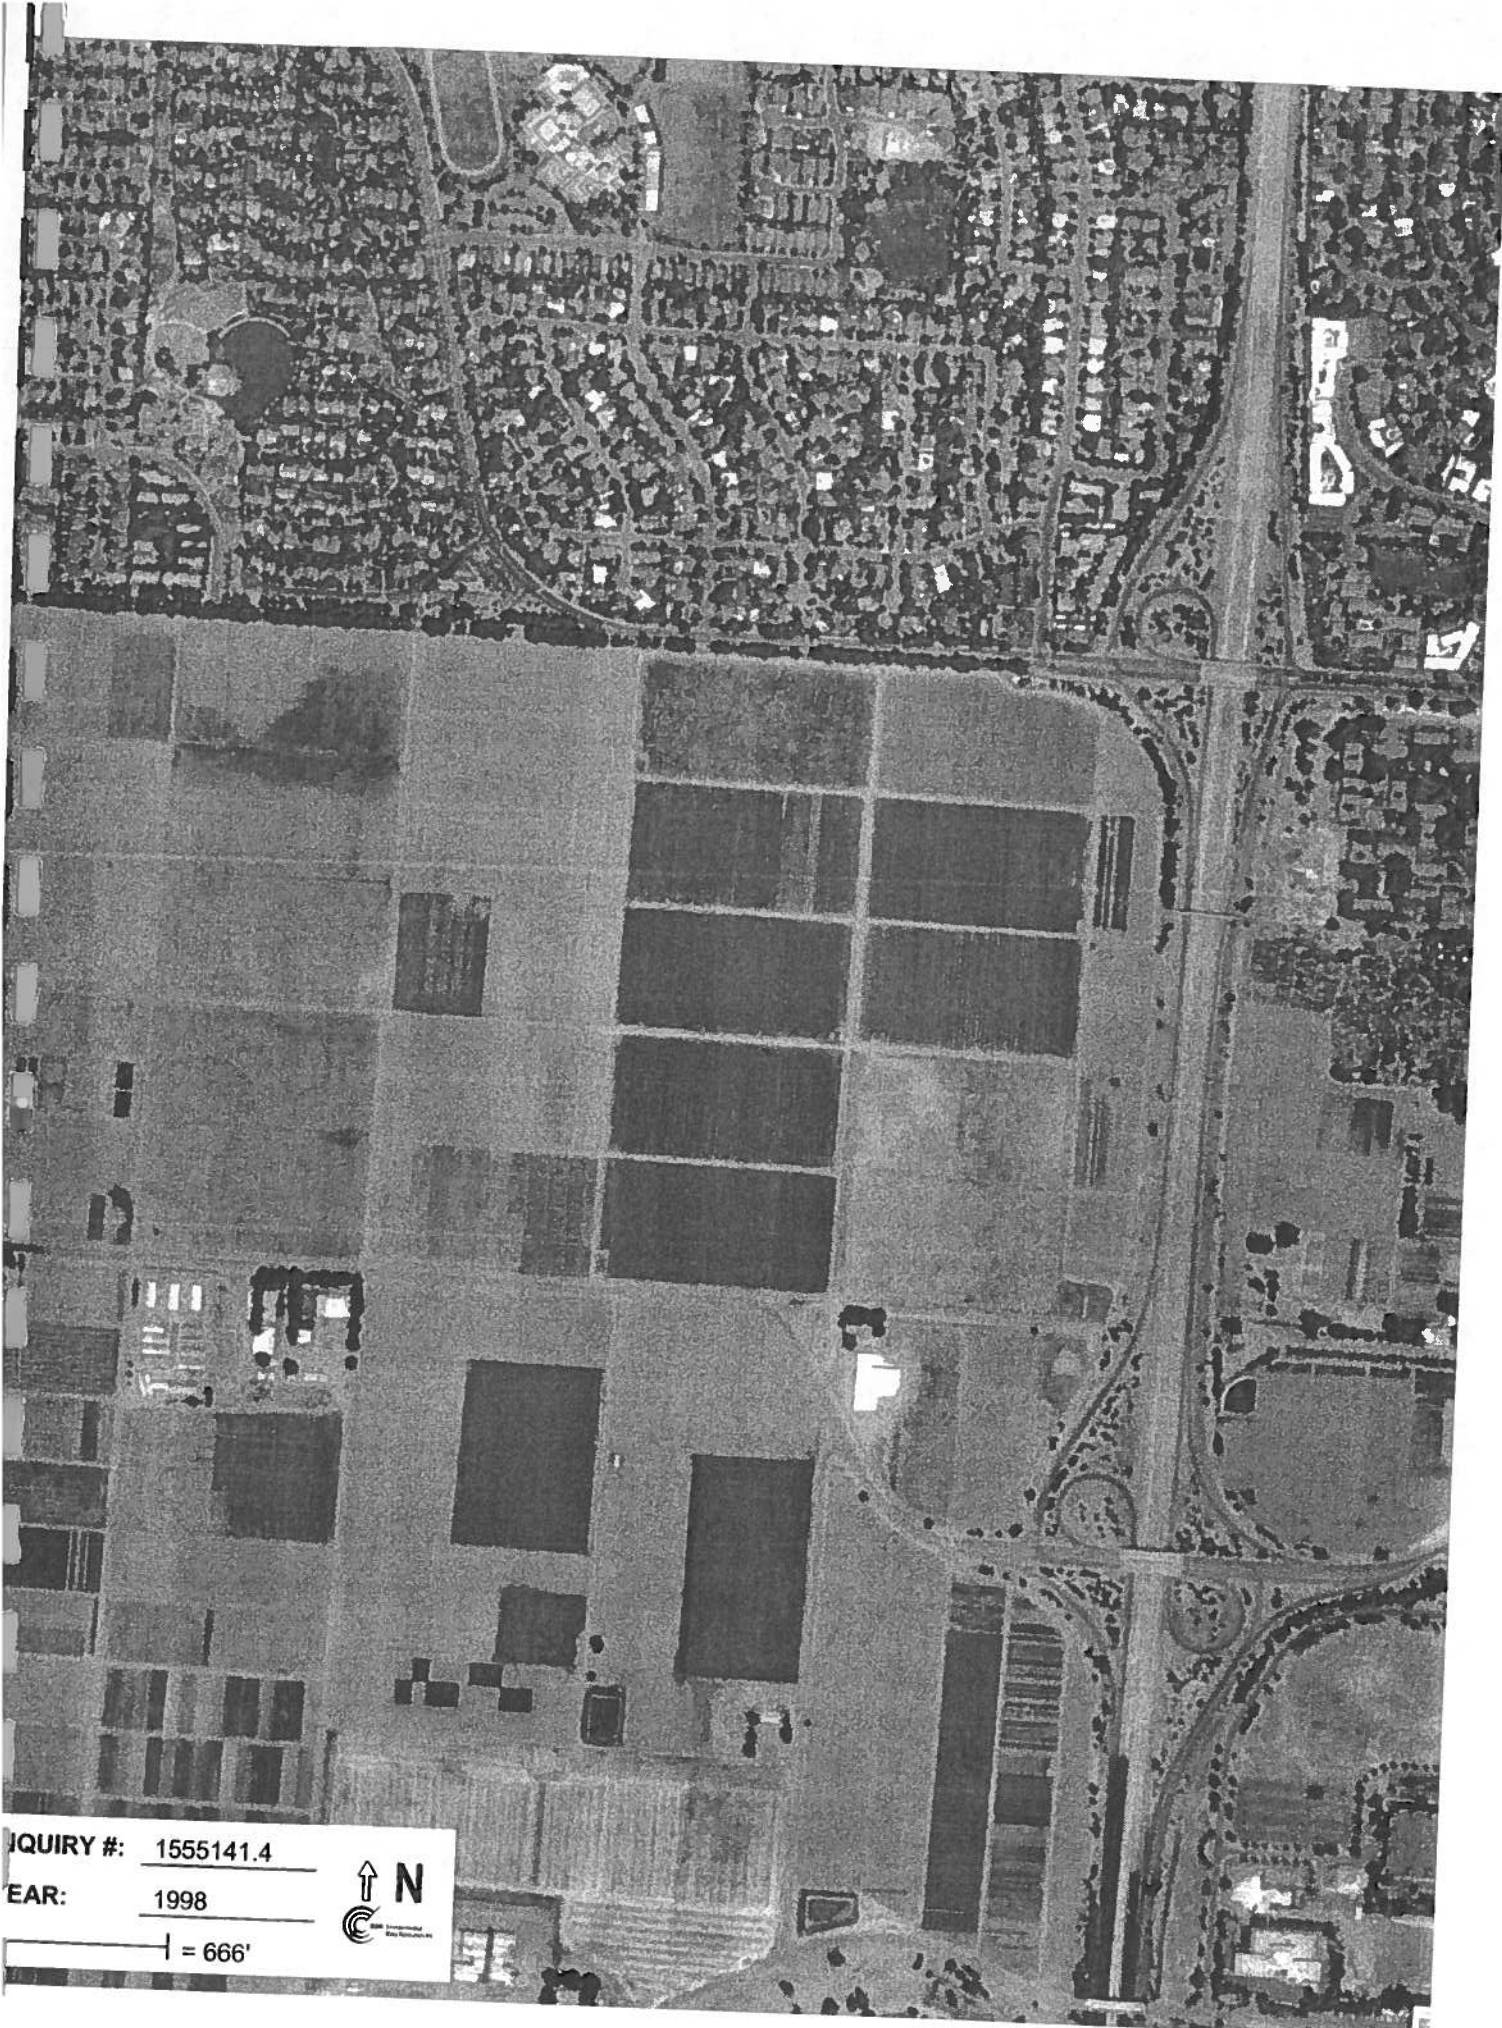
YEAR: 1998

No significant changes are noted on the 1998 aerial photograph relative to 1984 with the exception that the structure located in the southeast corner adjacent to the five silos is no longer visible. The five silos are still visible. The subject property is being utilized for agricultural purposes with the distinct plots readily visible in the photograph.
